MEDICAL IMAGING
CSO Customer Support Operations

Fieldservice Bulletin

Field Service Bulletin Nr. 11 for ADC Solo Type: 5155

Display of Digitizer claims "Empty Cassette"

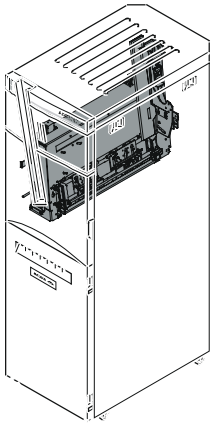
It can occur that the cassette opener loses the lid of the cassette during the opening process.

22481: "Timeout of stepper drive opener" or
22D40: “Empty Cassette”.

Inaccurately adjusted set screw at the cassette opener.

Adjust the set screw at the cassette opener manually.

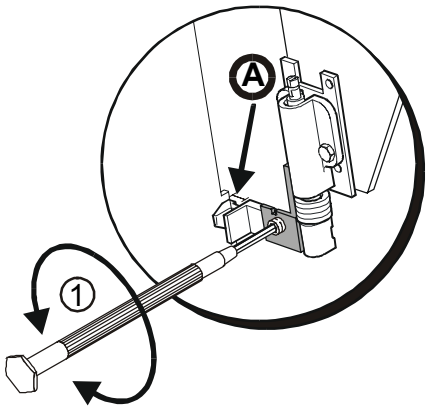
Figure 5

Check the position of the shank of the cassette opener (A) with the cassette pressed towards the right limitation of the cassette holder.
If it either pushes tightly to the cassette or leaves some space between cassette opener and cassette, the position of the cassette opener has to be adjusted.
In the perfect position, the shank of the cassette opener (A) softly touches the cassette.

11. Bring it to the perfect position by screwing the adjustment screw (1) either clockwise or counterclockwise.
12. Turn the red wheel (Figure 3 (1)) up and down several times, to check the function and the adjustment of the cassette opener. The result is satisfactory, if the cassette holder won´t loose the cassette lid.
13. If safety laquer at hand: add some safety laquer to the adjustment screw.
14. Close the ADC Solo again and switch on the digitizer.
